# AmeriSpec Home Inspection Services

Doc #: 200801-00XXX      Inspector: Herb Ingram NAHI 10-18767  
Date: 1/30/2008  
Dwelling Address: 1234 Main St.  
Anytown, PA  
Client Name: Anyone  
Client's Agent: Any Realtor      Real Estate Company: Realtor and Associates

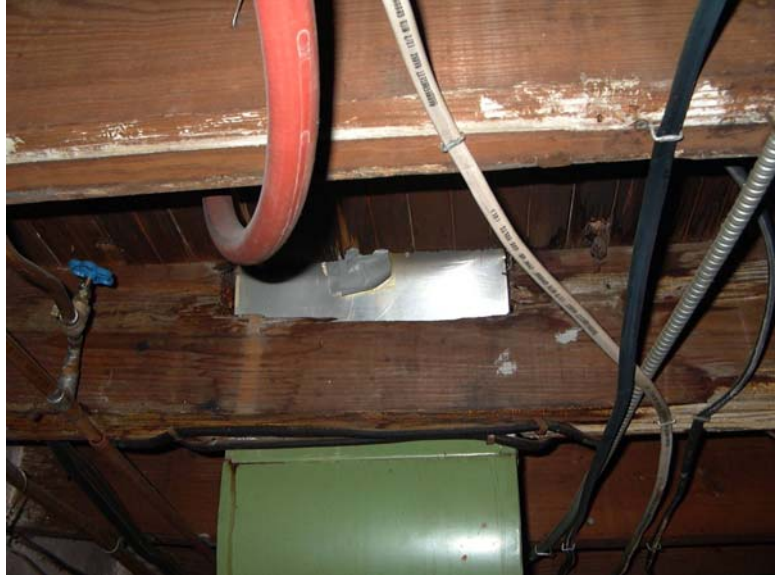
1704 Joists **Recommend Repair. Dimensional 2 x 10 framing. Joists have been improperly cut without installing headers at heat duct. Some joists are twisted at the ends. Consider correction or addition of more X cross members at the joists.**

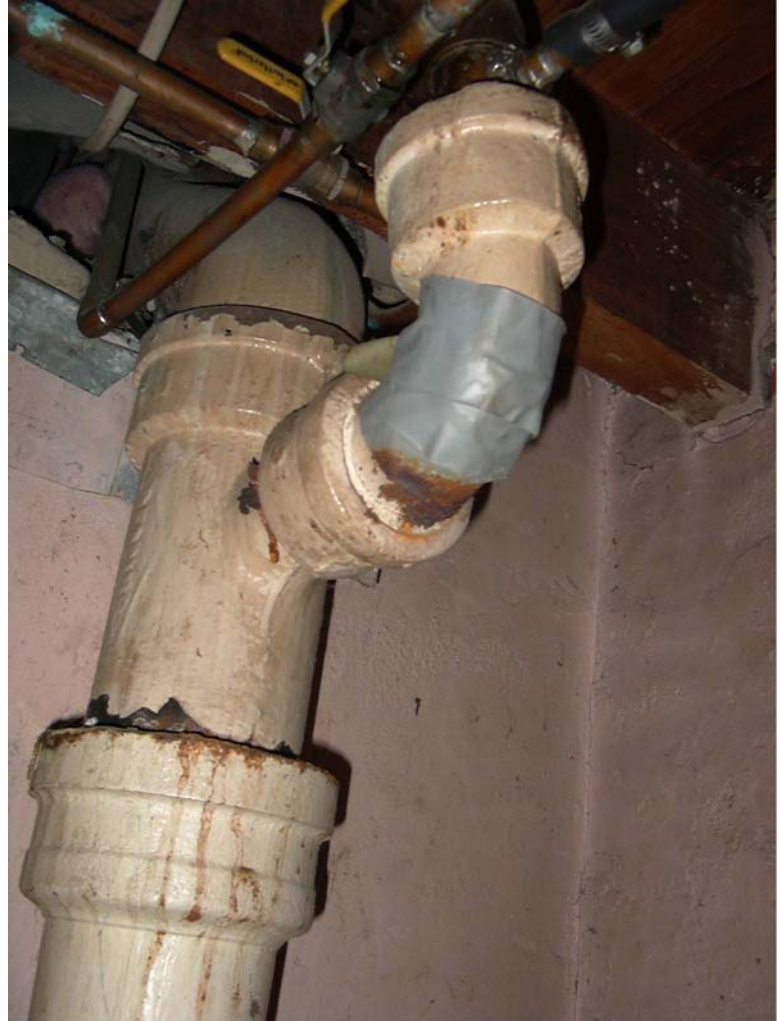
**Recommend Further Review.** Cast iron; Copper. This home has been vacant. Blockages or other issues may become apparent only after larger amounts of water or solids are introduced with habitation. **Rust, corrosion and tape with leak evidence was observed on the waste lines at basement left rear. Recommend review by a licensed plumber for repair or replacement, as necessary.**
