1000 Something Street, Somewhere, DE 19000

CLIENT & INSPECTION INFORMATION

CLIENT NAME: Mr. And Mrs. Quess.
INSPECTION #: 200708-000000
INSPECTION DATE: August 8, 2007
INSPECTION ADDRESS: 1000 Something Street, Somewhere, DE 19805.
AGENT / COMPANY INSPECTOR: Mr. Agent; RE/MAX
Lisa Roddis - ASHI #116319.
PARTIES PRESENT: Buyer(s). Buyers Agent.
HOUSE STATUS: Vacant.
AGE: 61 +/- years per property disclosure.
BUILDING TYPE: Townhouse.
STORIES: 2 story structure.
WEATHER: Sunny. Hot. Humid.
TEMPERATURE: 96 +/- degrees.
SOIL CONDITIONS: Dry.

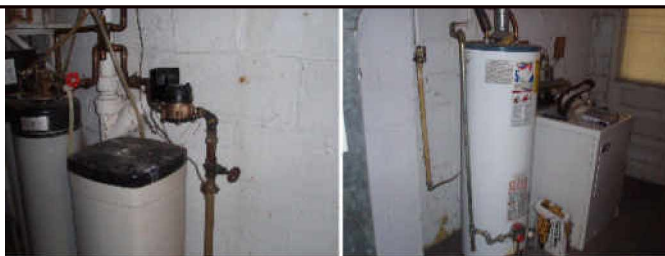
Monitor:	Supply: Galvanized pipes rust / corrode from the interior out and can become restricted over time which is indicated by low flow. Future repairs / replacement may be necessary.
Upgrade:	Waste: Negative drain pitch at kitchen sink & flex pipe at bath sink may cause drains to be slow, recommend correcting.
Defect:	Fuel: Gas: Copper pipe at dryer is considered improper as it bends easily, it is recommended to install rigid black pipe. Water Heater: TPR discharge pipe is missing, recommend installing to prevent scalding in the event of discharge. Supply: Significant leak at front hosebib packing.

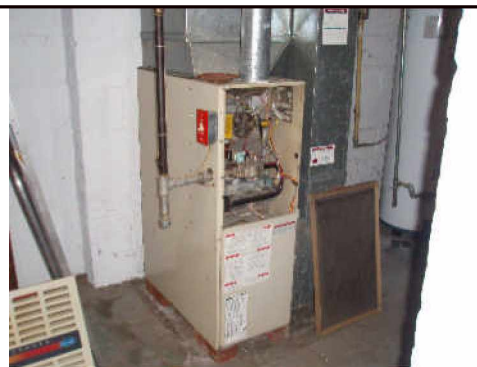
Maintenance: **Blower / Filter:** Dirty, recommend cleaning blower & replacing filter to enhance efficiency.

Monitor: **Age:** This is an older unit and may have a limited life expectancy.

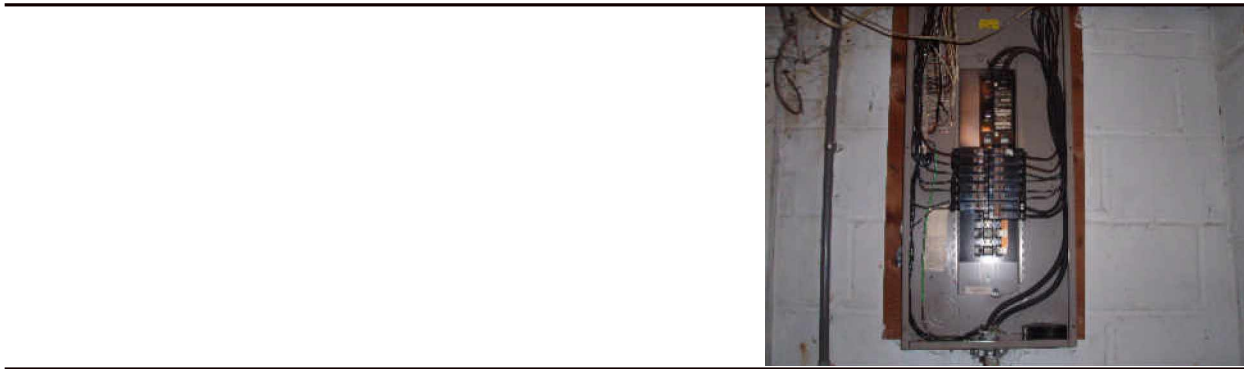
- Switches:**
 - > Reversed at front entry.
 - > Dimmer does not dim at kitchen.
- Outlets:** None present in bathroom, recommend installing to prevent the use of extension cords.

- Outlets:**
 - > Three prong ungrounded outlets present at: living room, kitchen which is a potential shock hazard. It is recommended that these outlets be grounded or installed on a GFCI circuit.
 - > Loosely attached at wall connection in kitchen and rear right bedroom which is a potential shock hazard, recommend securing.
 - > Not secured to wall at basement front.

Wiring / Outlet: Improperly run through front bedroom duct work; outlet is also improperly installed on same duct.
