**2921 Plum Leaf Circle
St. Charles, Missouri. 63303
(314) 308-6489**

Inspection No: 20070124h

Dwelling: 1234 Any Street
St. Louis, Missouri 63000

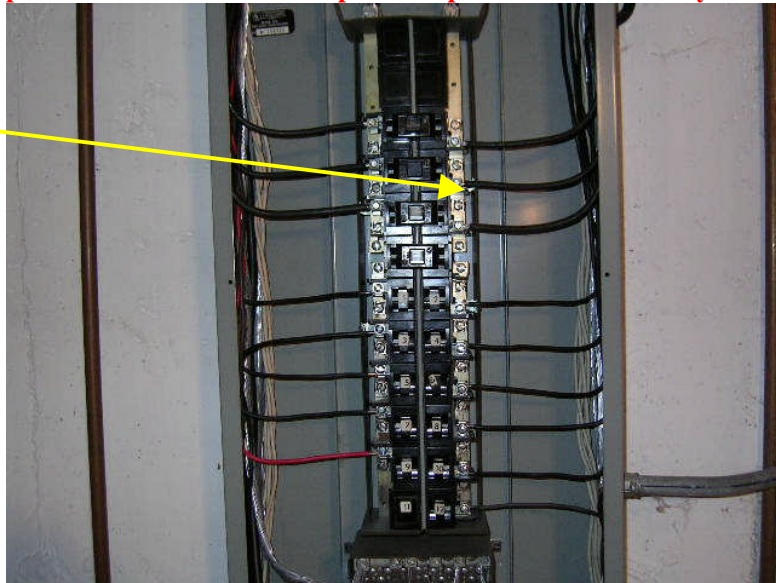
Step #	Component	Comments
1801	Electrical Main Service	Service entrance is underground.
1802	Main Electrical Panel & Location	Review. Service cables aluminum. Branch wiring copper. Futures. The electric panel is located in the basement. Overload protection provided by breakers. Double tapping observed at lower right 20-amp breaker. Double tapping (i.e. 2 wires on a single pole breaker) can add to the load of the affected circuit causing a possible overload and tripping breakers. Recommend review by a qualified professional electrician for repair or replacement as necessary.

Double tapping

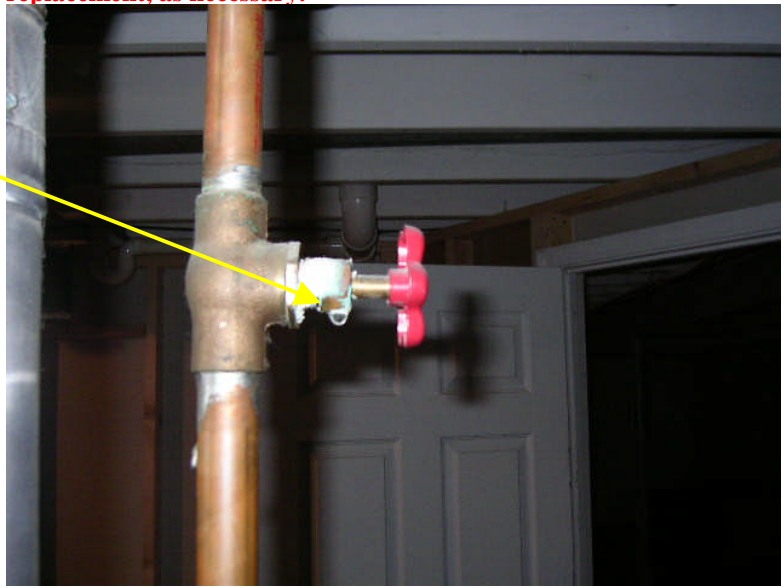
Step #	Component	Comments
2101	Location of unit	The water heater is located in the basement.
2102	Brand / Capacity	Manufactured by State. Capacity 40 gallons.
2103	Supply Lines	Copper. Rust and corrosion observed. Leaks visible at time of inspection. Recommend review by a licensed plumber for repair or replacement, as necessary.

Rust and Corrosion and leaks

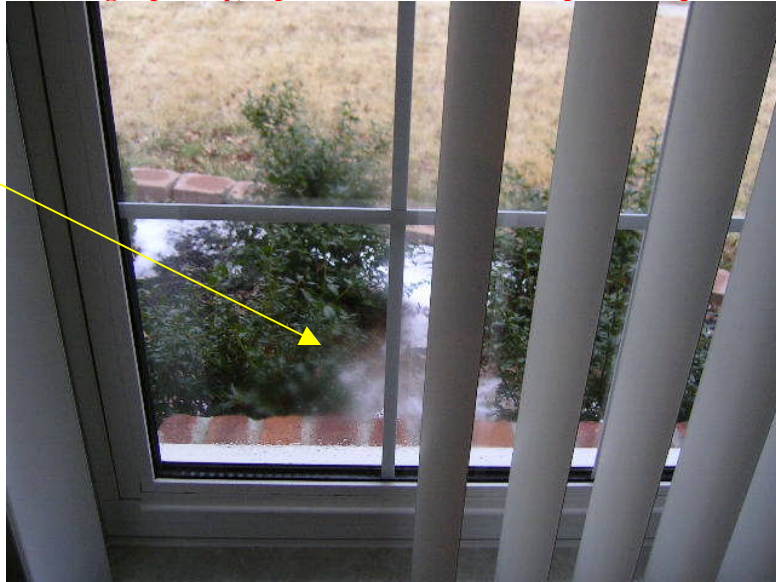
Review. Same type/material as house exterior windows, please refer to exterior step # 1105. Fog and condensation was noted in this double-glazed insulated windowpane at sink. This indicates a broken seal, which will reduce visibility and the insulating capability of this window. To restore visibility and regain the insulating capability, replacement of this windowpane is required.

Fog and condensation

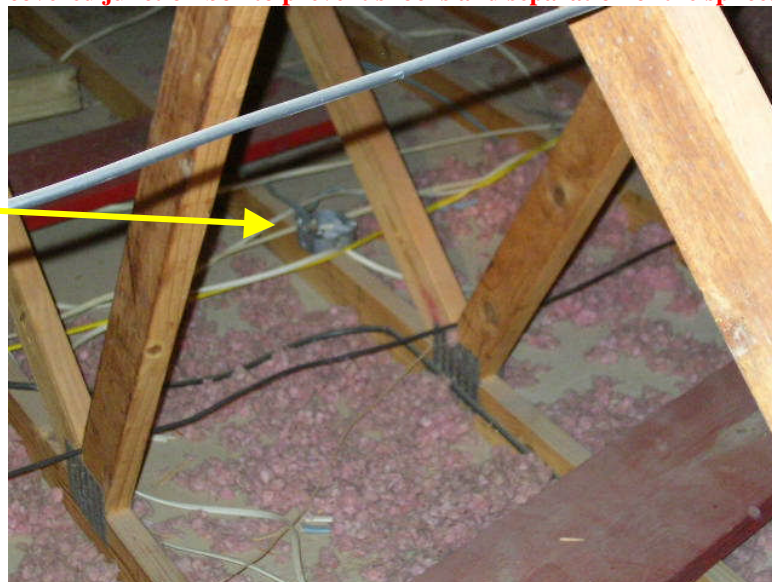
Step #	Component	Comments
2701	Access location / Inspection method	Comment. The attic access is located in the hall. The attic was entered and a visual inspection was performed.
2702	Framing	Serviceable. Trusses; 2x4.
2703	Sheathing	Comment. Plywood.
2704	Evidence of Leaking	Dry at time of inspection.
2705	Insulation	Serviceable. Fiberglass.
2706	Ventilation	Serviceable. Gable vents; Hooded roof vents; Soffit vents; Whole house fan.
2707	Windows	Not Present.
2708	Electrical	Open junction box was observed in the attic. Whenever an electric wire is cut and reconnected, the 'splice' should be encased in a covered junction box to prevent shocks and separation of the splice.

Open junction box
