AmeriSpec Home Inspection Service
1464 Madera Road, PMB N266
Simi Valley, CA 93065
(805) 522-2733 or (818) 883-8816

Inspection No: 200903-0XXX Inspector: Joe Nernberg

Inspection Date: 3/7/2009

Dwelling: 668 Over Drive
 Thousand Oaks, CA 91360

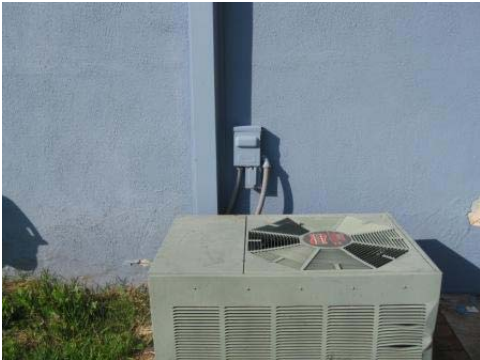
1107	Electrical Components	Flexible conduit is improperly lying directly on earth under the house. Improper clearance and working space to the electrical disconnect (serves the air conditioning unit). The unobstructed depth/horizontal clearance must be 30/36-inches.

Missing a ground conductor at same disconnect. A qualified licensed electrician should repair to ensure safety. Front light fixture inoperable at time of inspection. Possible burnt bulb. Suggest others to verify proper operation prior to closing.
1108	Gutters & Downspouts	There are no rain gutters to divert water away from the structure and ensure proper drainage. Suggest adding rain gutters and downspouts as needed.

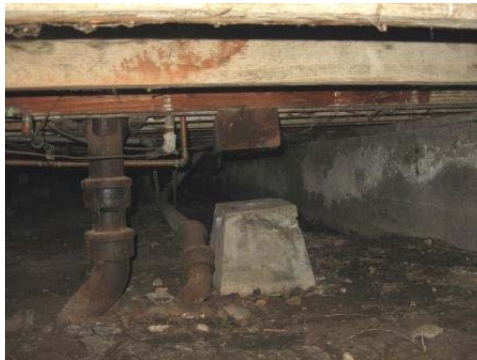
1113	Lot/Grade Drainage	Flat lot. Efflorescence found under this home suggests moisture intrusion. Recommend re-grading, flash wall(s) and/or others to repair exterior to keep moisture out of the sub area. Underground drainage system noted. It is beyond the scope of this inspection to inspect or perform tests on underground drainage systems. Client found drain piping to be broken and improperly discharges to the back yard. Concern about size of drain and point of discharge. Suggest repairs.
1114	Gas Meter	Located at the right side.
1115	Crawl Space/Sub Area	Suggest repairing the damaged vent screens to discourage further rodent/insect intrusion. Access located at the rear. Ventilation appears to be adequate. Suggest adding insulation under this home to improve comfort.
1116	Foundation	Raised concrete construction. Suggest repairing missing and displaced posts over piers.

Damaged wall at the master bedroom/bathroom may be attributed to this condition. The house is bolted to the foundation.

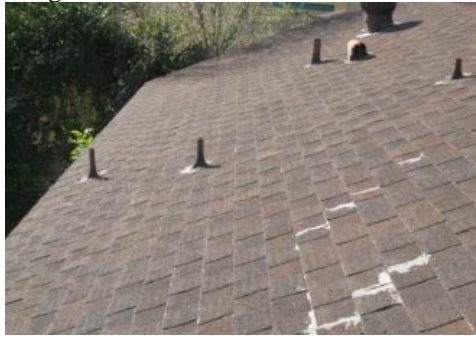
Step #	Component	Comments
1201	Roofing Type and Materials	Observed from the roof; Sloped construction. Composition shingle over wood shingles.
1203	Conditions	Improperly re-roofed. If the old flashing was in good condition, the lower part of the flange must be exposed and new shingles installed beneath same flange.

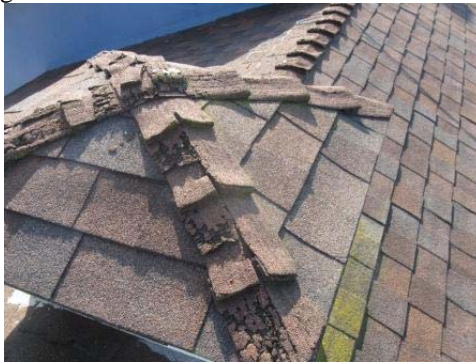
Evidence of patching is noted at several areas. Unable to determine the effectiveness of these repairs. Roofing materials are deteriorating and/or missing from several areas.

The rear field is at/or near the end of its useful life. Recommend a licensed roofing contractor to repair and evaluate the entire roof system prior to the close of escrow.

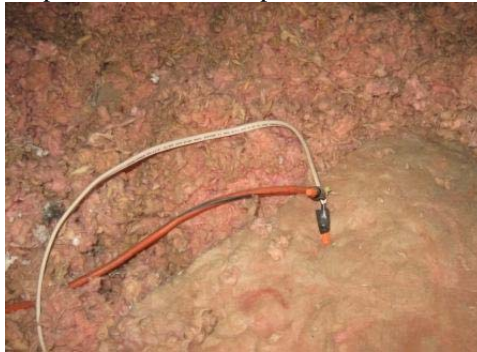
Step #	Component	Comments
1251	Access	Attic access is located at the master bedroom closet. Limited access due to narrow areas.
1252	Framing	Serviceable.
1253	Sheathing	Spaced 1" x 6". Moisture stains noted. Cannot determine if stains are active or passive.
1254	Insulation	Blown in. Insulation is approximately 6-inches thick.
1255	Ventilation	Gable vents.
1256	Electrical	Open electrical splices noted at multiple areas.

Whenever electrical wires are cut and reconnected, the 'splice' should be encased in a covered 'junction box' to ensure safety and protect the wires. Extension cord-like conductor is not approved. A qualified licensed electrician should repair for safety. Unfastened conductors/wiring at the attic. Nonmetallic-sheathed conductors should be supported and secured by staples, cable ties, straps or hangers at intervals not to exceed 4.5-feet and within 12-inches of every outlet/junction box. Safety concern.

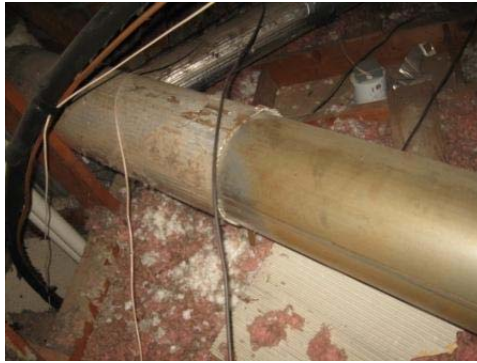
Step #	Component	Comments
1401	Heating	Gas; Forced air. Unit is located at the entry area.
1402	Conditions	Serviceable.
1403	Exhaust Venting	Serviceable.
1404	Thermostat	Serviceable. Thermostat is located at the hall.
1405	Ducting	Damaged asbestos ducts at the attic.

Intact or sealed (painted or taped over) asbestos is not harmful unless it becomes friable. Friable means the material can be easily crushed or pulverized to a powder by hand pressure. Friable materials have a higher potential to release fibers. This is a possible health and safety concern. Ducts may not be sized for cooling. Return air register not allowed at the kitchen. Suggest further review/repairs/replacement by a qualified licensed asbestos/HVAC contractor prior to closing.

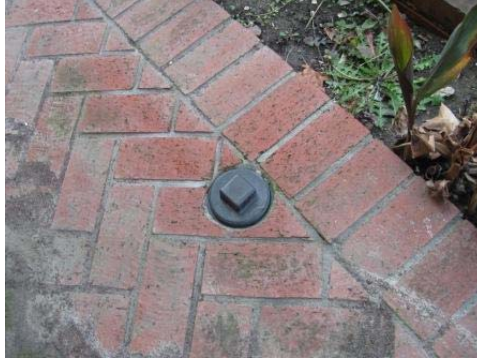
Step #	Component	Comments
1501	Plumbing Supply System	Water was off initially. Listing agent permitted inspector to turn on water for the inspection and listing agent is responsible for conditions which may arise in this vacant home. Pressure was within normal range of 40 to 80 psi. Shut off location is at the front. Property has public water supply.
1502	Plumbing Sewer System	There may be an underground sewer concern. There is a newer yard cleanout valve that is consistent with drain cleaning.

Recommend seller disclosure and/or a plumbing/drain cleaning service to determine if there is a collapsed or damaged sewer prior to the close of escrow.

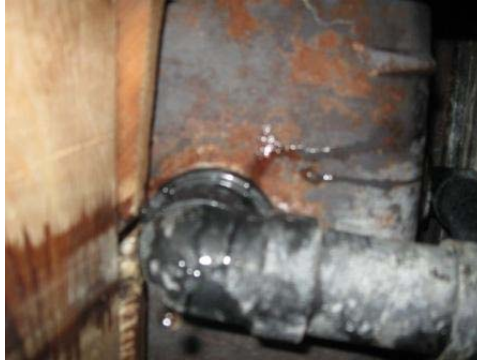
1503	Water Piping	Copper. Suggest insulating water lines. Leaking icemaker valve. Suggest repair.
1504	Waste/Drain Pipes	Galvanized; Cast iron; Plastic. Waste line is leaking at the tub.

Suggest repairs/replacement under the house.

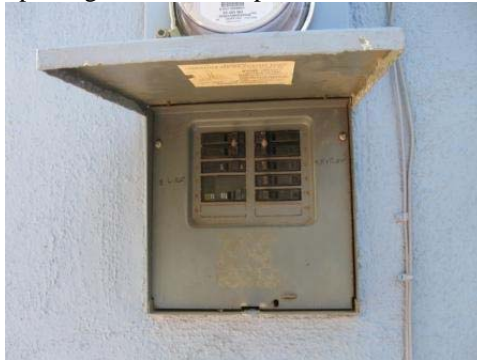
Step #	Component	Comments
1601	Electrical Main Box/Panel	Recommend replacing this electrical panel.

No main disconnect provided at this equipment as is required when there are 6 switches/circuit breakers or more. Expansion of this system is contrary to the manufacturer installation instructions. Further, black conductor should not be used as a neutral/common conductor and pointed screw is not allowed to fasten the dead-front cover. The main panel is located at the rear. Service entrance is overhead. This house is equipped with a two wire non-grounded system which was standard at the time of construction. Receptacles near water sources and at exterior locations ideally should be grounded. Because of the age or configuration of this system, we are unable to determine if grounding is in place or can occur. Suggest review by a qualified licensed electrician to determine the feasibility of GFCI receptacles in lieu of grounding for wet locations to ensure safety. Conductors are copper, preferred for safety. Recommend legible identifying each circuit as to purpose or use on the face or inside the electrical panel door.

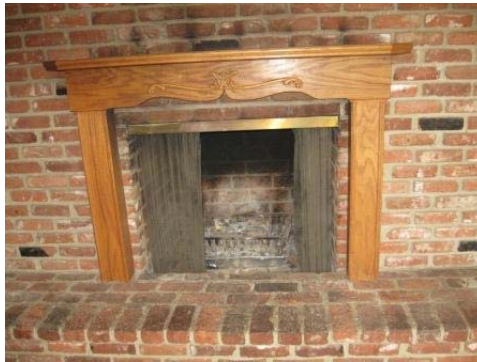
Step #	Component	Comments
2001	Floor	Serviceable. Wood.
2002	Walls	Drywall. Cracks noted.
2003	Ceiling	Drywall. Discoloration noted.
2004	Doors	Sliding glass. The glass is tempered.
2006	Electrical	The non-metallic sheathed wiring is exposed near the switches. These conductors are normally used inside walls where they are not subject to damage. A qualified licensed electrician is recommended for proper installation of wiring and receptacles. See also 2407.3 comments.
2007	Heat Source	Forced air register observed.
2020	Fireplace	Improper clearance to combustibles.

Combustible construction cannot be installed within 6-inches of the fireplace opening. A 1-inch clearance is needed for each 1/8-inch of projection within 12-inches of same fireplace opening. Recommend correcting for safety. Gas starter provided. Recommend cleaning the chimney flue prior to using.

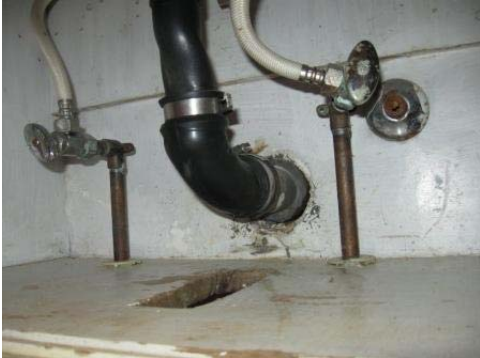
2318	Traps/Drain Supply	Missing a sink trap. Rubber drain is not approved. Suggest repair.
