PROPERTY INSPECTION REPORT

Prepared For: Sample (Name of Client)
Concerning: Sample (Address or Other Identification of Inspected Property)
By: Chesley D Graham TREC 4516 3/27/2008 (Name and License Number of Inspector) (Date)
(Name, License Number and Signature of Sponsoring Inspector, if required)

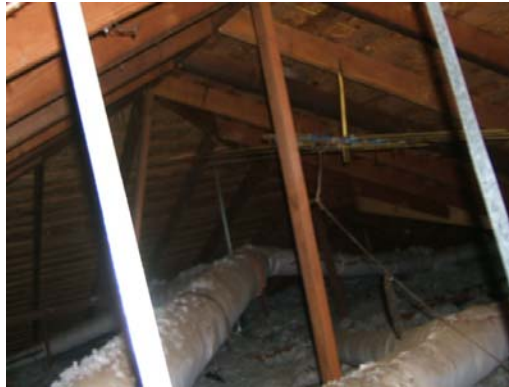
Ideally, collar ties (horizontal members running between each rafter, near their mid-span) should be provided for all rafters. Collar ties help to resist rafter sag. Installation is usually very simple.

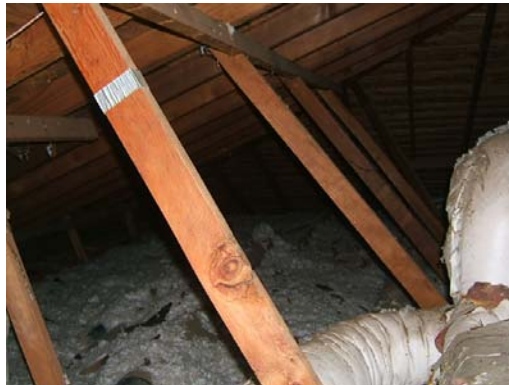
The purlins are undersized. Purlins run horizontal support for the rafters and should be the same size as the rafter they support.

The ridge boards are undersized; they should be the same size as the cut ends of the rafters. Undersized ridge boards can cause rafter to spit. This is simple repair.

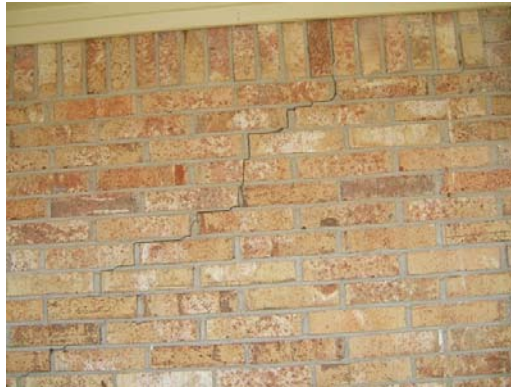
Pronounced exterior wall cracks were observed at the back yard side of the garage. This implies that structural movement of the building has occurred. The rate of movement cannot be predicted during a one-time inspection. A structural engineer should be consulted to further evaluate this condition and the remedies available for correction.

The brick veneer crack needs to be repaired.

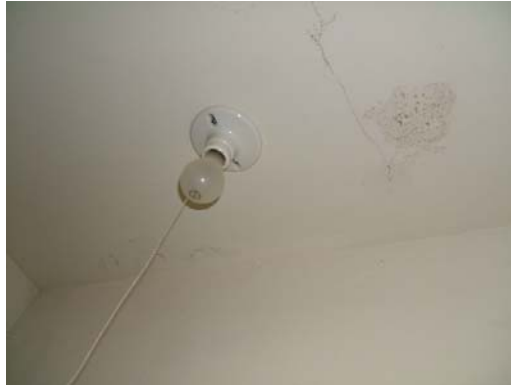
The ceiling in the hall bath and the closets of the front bedroom are termite damaged and should be repaired once the termites have been treated.

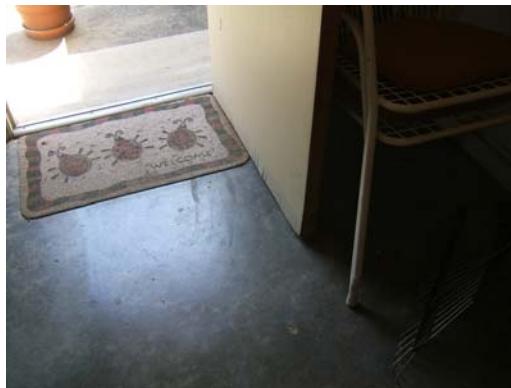
The garage exit door to the back yard needs to be trimmed and adjusted to work properly.

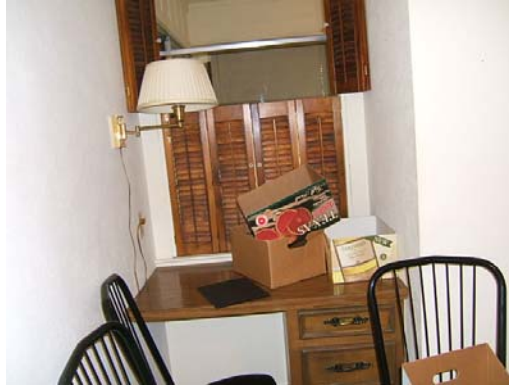
The window in the bedroom attached to the sun room does not allow for egress to the exterior

The sill height in the master bedroom is too high for fire egress. Enlarging the opening is advisable.

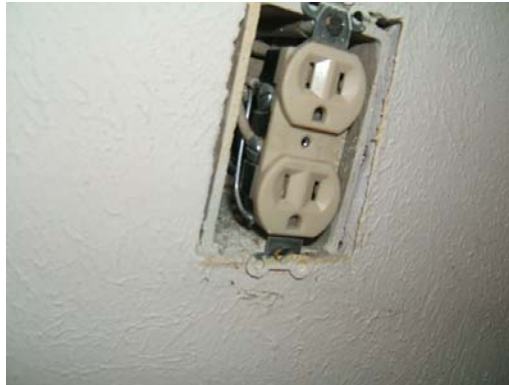
The aluminum wiring should be fitted with special connectors and outlets to ensure safe operation of these circuits. During installation of this special hardware, all connections should be checked for signs of damage or overheating. *It should be pointed out that the aluminum wiring itself is a perfectly acceptable electrical conductor.* The connection points can experience overheating or become loose due to the properties of aluminum wiring. Upon fitting the wiring with the special connectors and outlets, the wiring is considered to be safe.

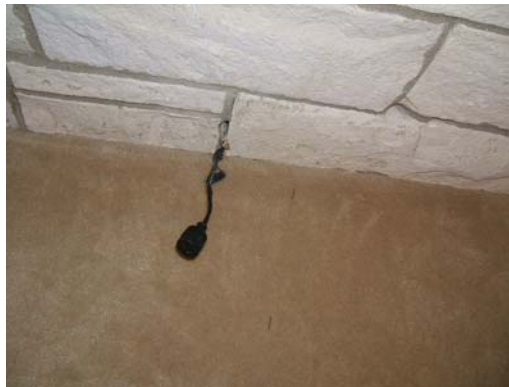
The wiring behind the fireplace needs to be removed and properly discontinued.

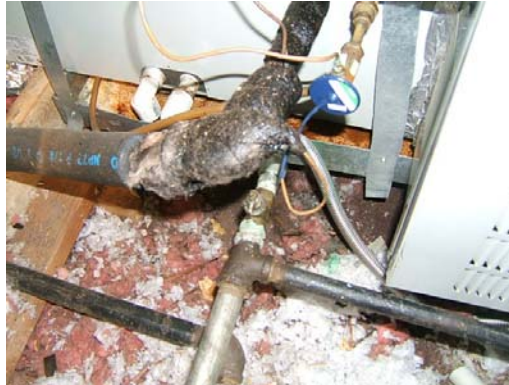
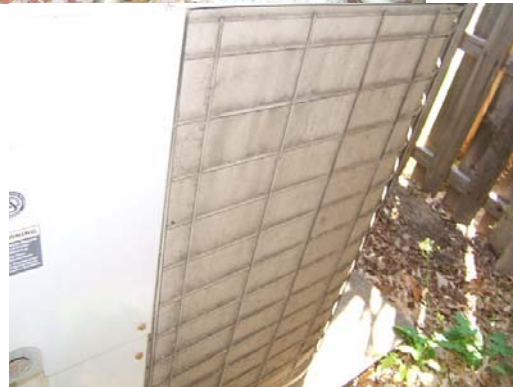
The outdoor unit of the air conditioning system requires cleaning.

The auxiliary drain pan installed below the air conditioning system contains water and debris, the secondary line drips constantly while running. This should be emptied and cleaned. The pan has rusted; the cause of the rust should be determined by a licensed HVAC technician.

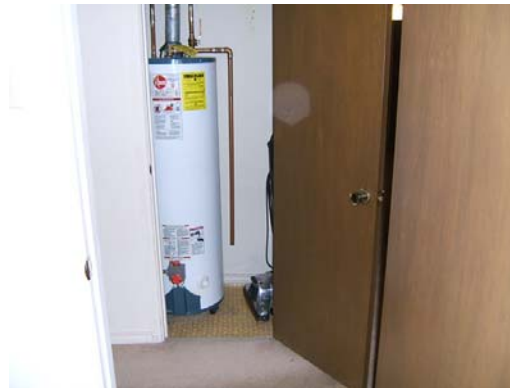
The water heater is an older unit that may be approaching the end of its useful life. It would be wise to budget for a new unit. One cannot predict with certainty when replacement will become necessary.

The discharge piping serving the Temperature and Pressure Relief (TPR) Valve for the water heater should terminate to the buildings exterior and not less than 6 inches or more than 24 inches above the ground. Repairs should be undertaken.

No safety pan and drain was found for the water heater. This should be repaired by the installation of a pan with a drain by a qualified professional

It is suspected that there is an insufficient supply of combustion air for the water heater. *Improvement is usually straightforward, and should be considered high priority for safety reasons.*

The repairs to the units will have to be made when replaced is needed.
