PROPERTY INSPECTION REPORT

Prepared For: Sample (Name of Client)
Concerning: Sample (Address or Other Identification of Inspected Property)
By: Chesley D Graham TREC 4516 3/27/2008 (Name and License Number of Inspector) (Date)
(Name, License Number and Signature of Sponsoring Inspector, if required)

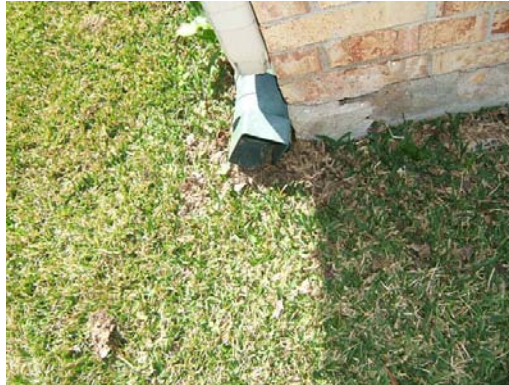
The foundation is not performing as intended. See additional comments below. Cracks were observed on the exterior walls of the house at the garage. This implies that some structural movement of the building has occurred, as is typical of most houses. Surface deterioration (known as spalling) was observed on the exterior of the exposed foundation walls. This condition is common in many homes and does not usually represent a structural concern. In an effort to prevent long term deterioration, it would be wise to consider parging deteriorated areas.

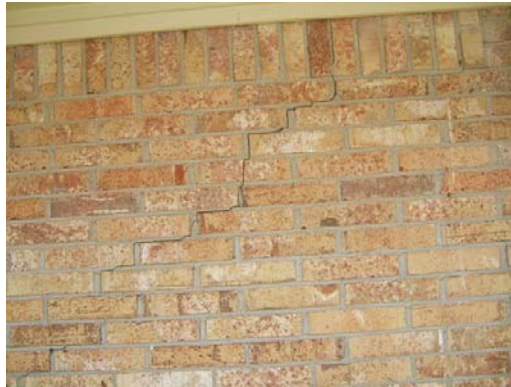
Pronounced exterior wall cracks were observed at the back yard side of the garage. This implies that structural movement of the building has occurred. The rate of movement cannot be predicted during a one-time inspection. A structural engineer should be consulted to further evaluate this condition and the remedies available for correction.

The brick veneer crack needs to be repaired.

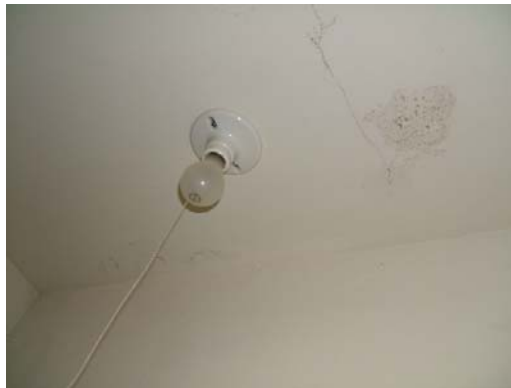
The ceiling in the hall bath and the closets of the front bedroom are termite damaged and should be repaired once the termites have been treated.

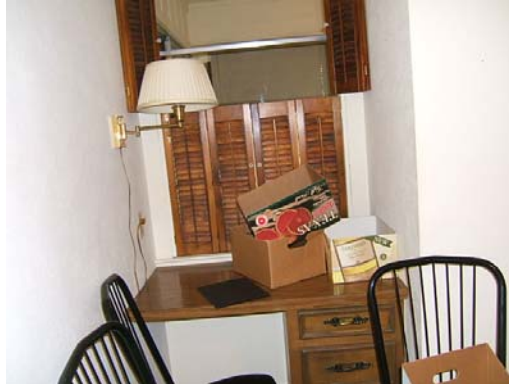
The window in the bedroom attached to the sun room does not allow for egress to the exterior

The sill height in the master bedroom is too high for fire egress. Enlarging the opening is advisable.

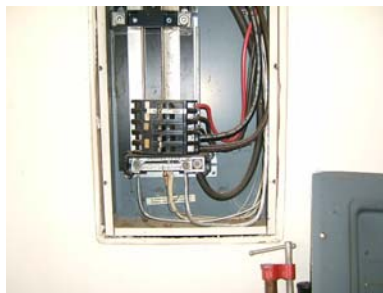
A. Service Entrance and Panels

Comments: Aluminum

The aluminum wiring should be fitted with special connectors and outlets to ensure safe operation of these circuits. During installation of this special hardware, all connections should be checked for signs of damage or overheating. *It should be pointed out that the aluminum wiring itself is a perfectly acceptable electrical conductor.* The connection points can experience overheating or become loose due to the properties of aluminum wiring. Upon fitting the wiring with the special connectors and outlets, the wiring is considered to be safe.

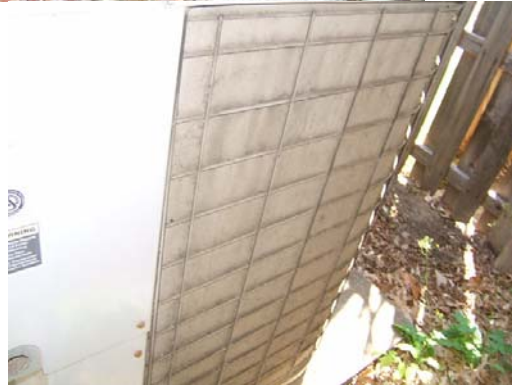
The outdoor unit of the air conditioning system requires cleaning.

The auxiliary drain pan installed below the air conditioning system contains water and debris, the secondary line drips constantly while running. This should be emptied and cleaned. The pan has rusted; the cause of the rust should be determined by a licensed HVAC technician.

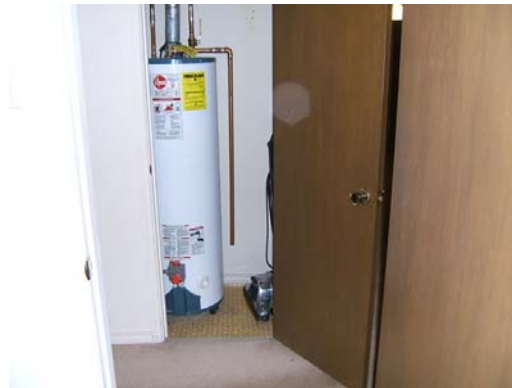
The water heater is an older unit that may be approaching the end of its useful life. It would be wise to budget for a new unit. One cannot predict with certainty when replacement will become necessary.

The discharge piping serving the Temperature and Pressure Relief (TPR) Valve for the water heater should terminate to the buildings exterior and not less than 6 inches or more than 24 inches above the ground. Repairs should be undertaken.

No safety pan and drain was found for the water heater. This should be repaired by the installation of a pan with a drain by a qualified professional

It is suspected that there is an insufficient supply of combustion air for the water heater. *Improvement is usually straightforward, and should be considered high priority for safety reasons.*

The repairs to the units will have to be made when replaced is needed.
