**AmeriSpec Home Inspection Service**  
**2205 Eastchester Drive, Suite 101**  
**High Point, NC 27265**  
**(336) 841-1080 Fax (336) 841-1085**

Inspection #: 200709-11357  
Address: 1234 Pleasant Lane  
Your Town, NC 27265

Inspection #: 200709-11357 Inspector: Donald C. Bedner  
Date: 9/21/2007  
Address: 1234 Pleasant Lane  
Your Town, NC 27265  
Client Name: John Q. Homebuyer  
Client Agent: I. M. Goodagent Real Estate Co.: Mega Bucks Realty

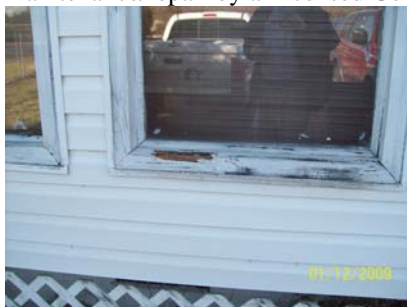
1106. Windows & Frames

Recommendation. Deterioration noted to both fixed windows on left side of house. Additional areas other than the locations noted might be in need of repair, which may only be visible during repairs. Recommend maintenance/repair by a Licensed General Contractor.
