AmeriSpec of NE Florida, Inc.

Doc #: SAMPLE

Date: 1/28/2009

Dwelling Address: 3000 Jacksonville Blvd.

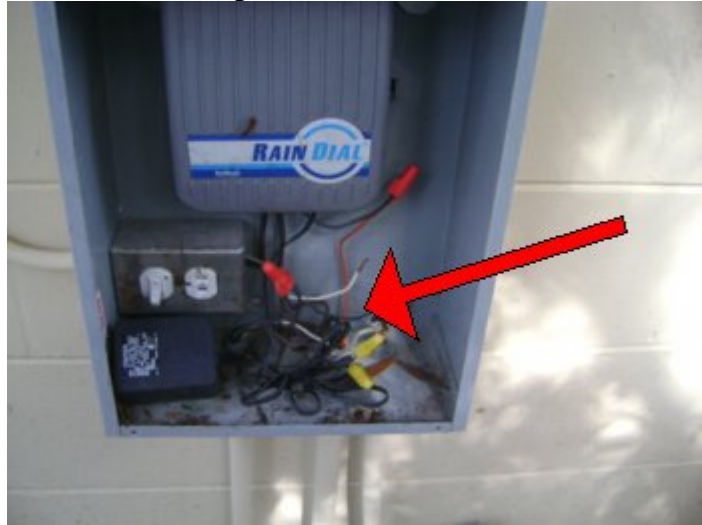
- Irrigation timer is located inside a metal enclosure on the left side. There is a large open splice that is not protected and is accessible to anyone needing access to timer and electrical outlet. Repair as needed.

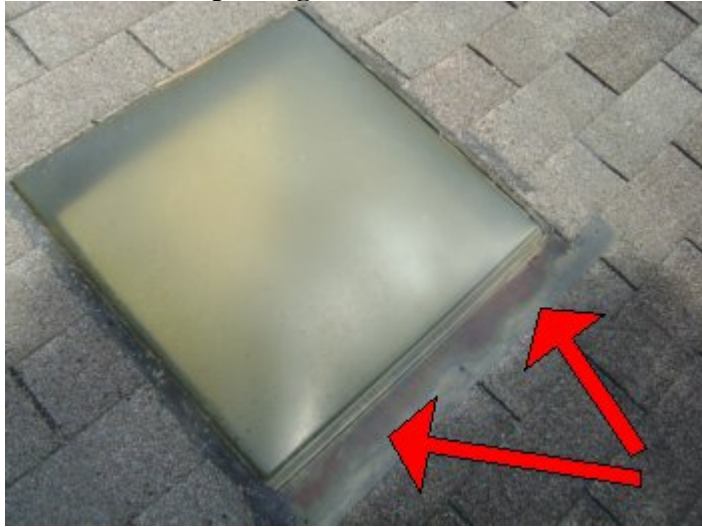
1204 Skylights

REPAIRS ARE RECOMMENDED.
Fiberglass/plastic, integral flashing. Cracked.
Recommend replacing.

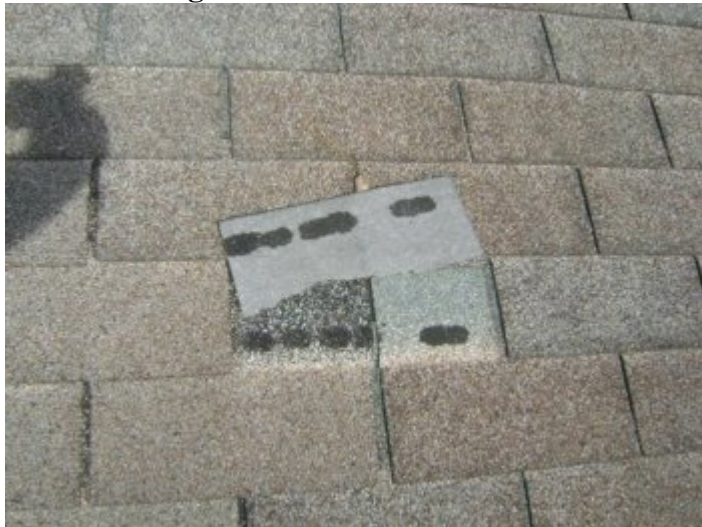
1205 Conditions

REPAIRS ARE RECOMMENDED.

- **Older roof that needs several immediate repairs where shingles are damaged and/or missing.**

- **No shingle adhesion. Limited remaining life as there is high wind risk associated with shingle tabs that lack adhesion.**

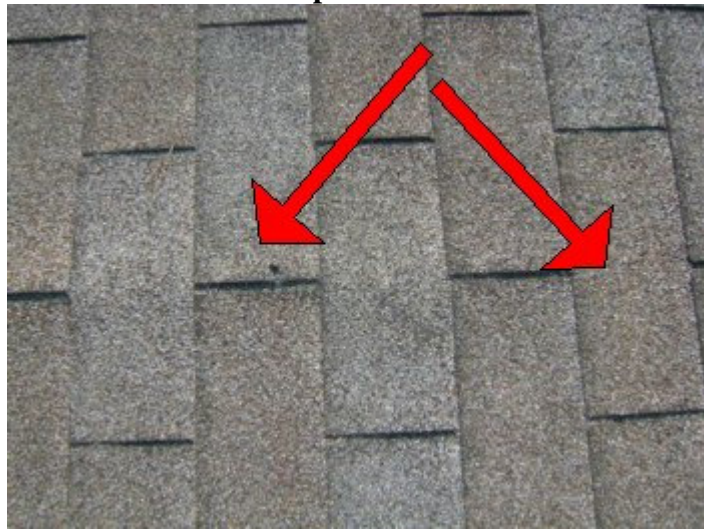
1206 Roof Comments

REPAIRS ARE RECOMMENDED.

- **The starter course of shingles have not been sealed along the eaves as recommended by most shingle manufacturers. A properly installed started course is important to prevent high wind damage along the eaves. In most cases a qualified roofing contractor can install roofing adhesive along the eaves to provide an immediate remedy.**
- **Roof deck not fastened or ply clip has loosened at left front. A qualified roofer is needed to evaluate and repair as needed.**

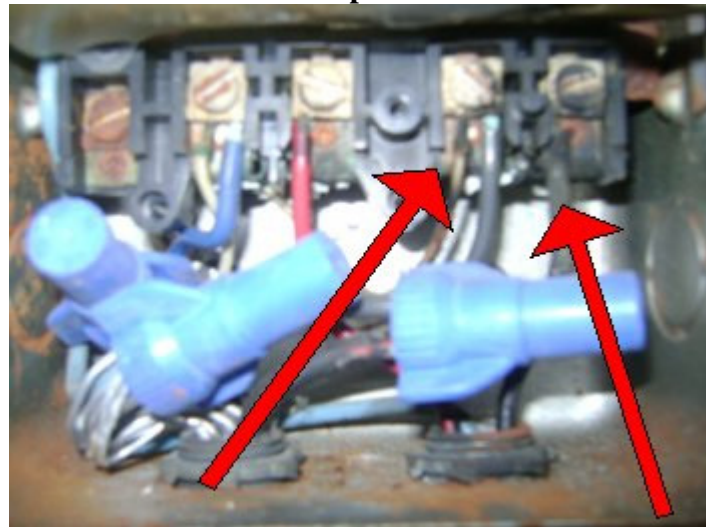
Step #	Component	Comments
2101	Location of unit	The water heater is located in the garage.
2102	Water Heater Design Type	Electric.
2103	Brand / Capacity	50 gallon. Manufactured by Kenmore.
2104	Supply Lines	Serviceable.
2105	Energy Source	ELECTRICAL SAFETY ITEM. Visible electrical short at timer. A qualified electrical contractor is needed to evaluate and repair as needed.

2106	Temperature / Pressure Release Valve	Serviceable.
2108	Water Heater Condition	MFD 2000. See 2105 above.
2110	Overflow Pan / Drain Line	None.
2111	Water Heater Comments	None.

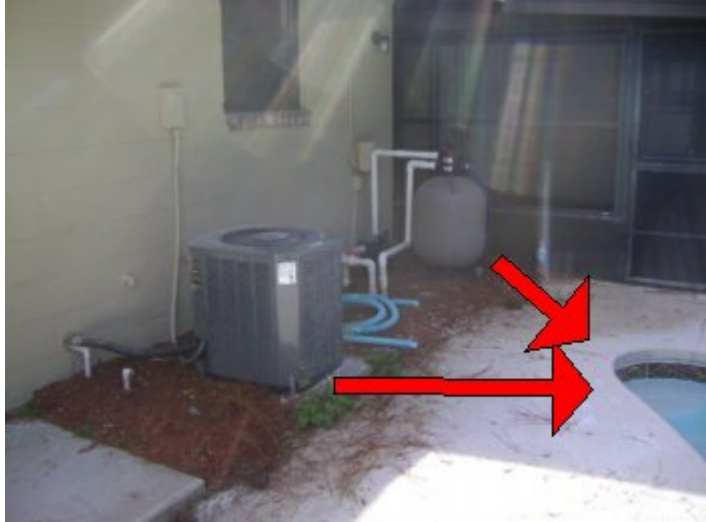
Step #	Component	Comments
2801	Pool Deck	Serviceable. Concrete with textured surface.
2802	Pool Walls/Liner/Tile	Serviceable. Marcite.
2804	Fencing	IMPROVEMENTS ARE SUGGESTED. Wood. Need self closing and latching hardware. Typical conditions (decay) for age and type.
2807	Heating Source	None.
2808	Electrical	IMPORTANT COMMENTS. There are multiple, energized electrical components within five to ten feet of water line. If built today this would not be allowed. We encourage installation of a screening wall/fence to prevent direct access to energized components. Discuss bonding condensing unit to pool equipment.

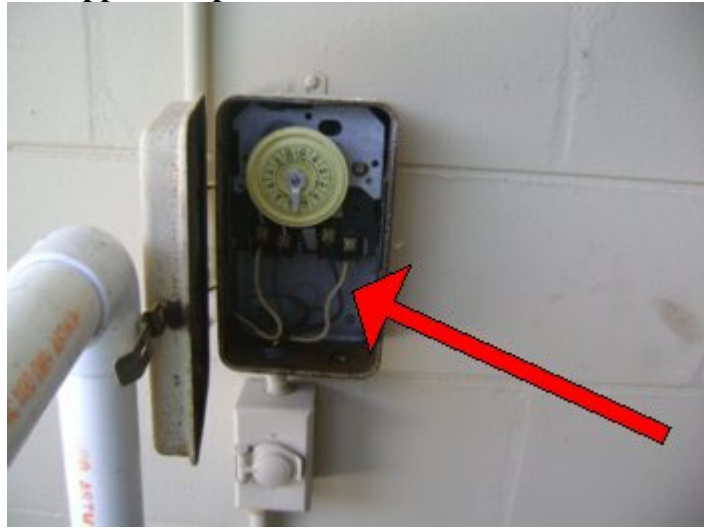
2813 Timing Device/Control

ELECTRICAL SAFETY ITEM. Insulator missing; no trippers. Repair as needed.
