PROPERTY INSPECTION REPORT

Prepared For: Sample (Name of Client)
Concerning: Sample (Address or Other Identification of Inspected Property)
By: Chesley D Graham TREC 4516 3/27/2008 (Name and License Number of Inspector) (Date)
(Name, License Number and Signature of Sponsoring Inspector, if required)

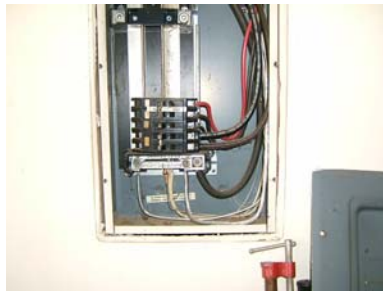
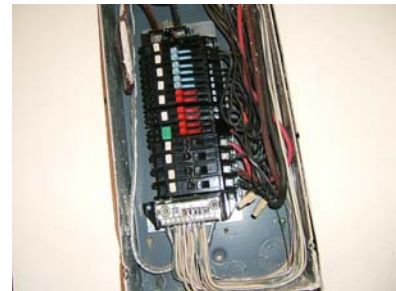
A. Service Entrance and Panels

Comments: Aluminum

The aluminum wiring should be fitted with special connectors and outlets to ensure safe operation of these circuits. During installation of this special hardware, all connections should be checked for signs of damage or overheating. *It should be pointed out that the aluminum wiring itself is a perfectly acceptable electrical conductor.* The connection points can experience overheating or become loose due to the properties of aluminum wiring. Upon fitting the wiring with the special connectors and outlets, the wiring is considered to be safe.
